## Results of Tipper Test

## Measurement Procedure

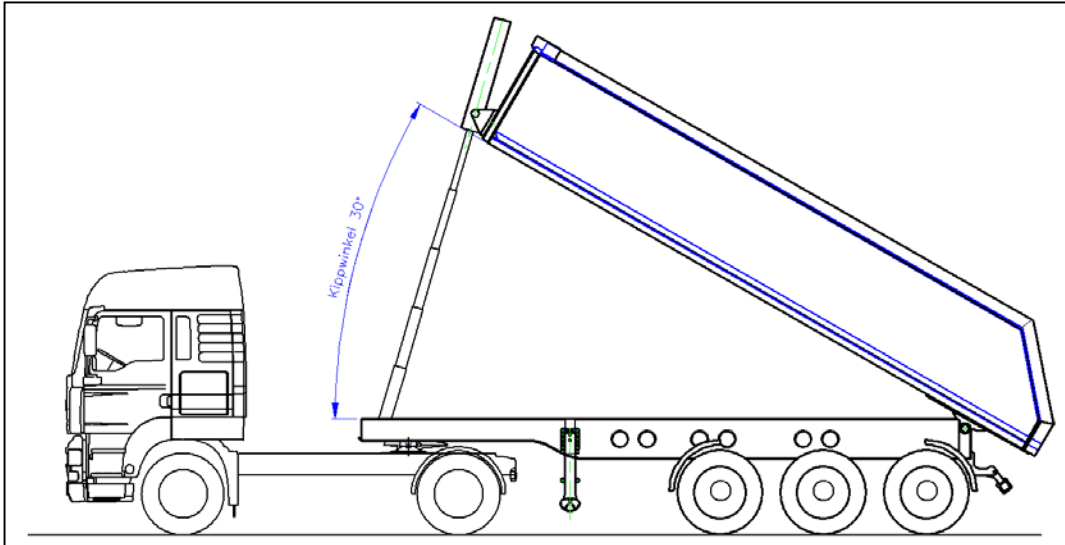
### Tip Angle 30 °

In total two different tests were carried out. It was important that all vehicles were subject to the same conditions. Each trough was loaded up to 25 tonnes. In the first test (see data sheet 1, measurements from 1 July 2008) the trough was first tipped to an angle of 30 degrees and then the vehicle was inclined to an angle of 6 degrees.

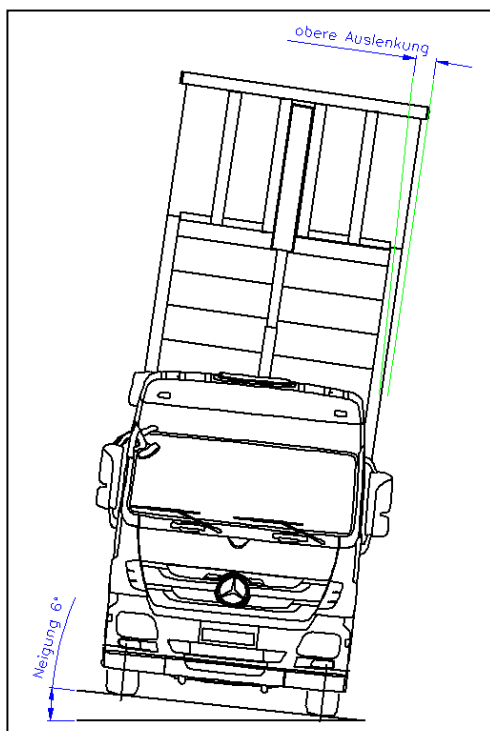
### Roadway Inclination 6 °

In the second test (see data sheet 2, measurements from 2 July 2008) the vehicle was first inclined to an angle of 6 degrees and then the trough was tipped to an angle of 30 degrees.

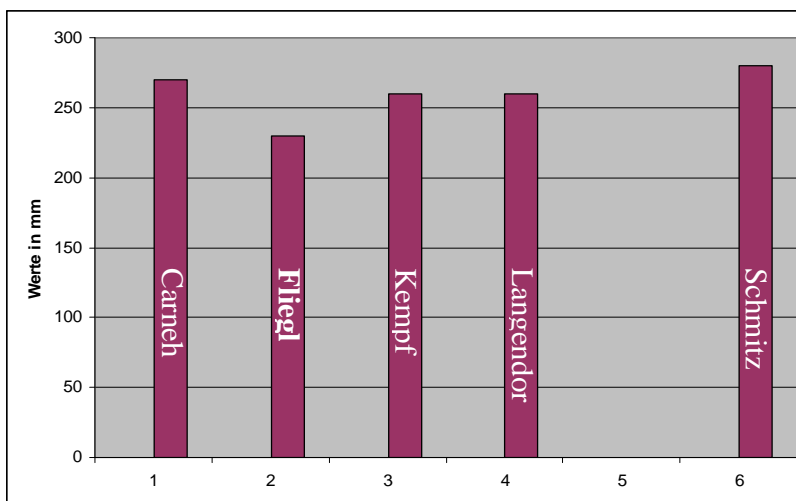
### **1. Upper deflection trough (2<sup>nd</sup> test day)**

**For this measurement the load of 25 tonnes was evenly distributed over the whole loading platform. The reason for the measurement is; to obtain an, as low as possible value of the upper deflection during the tipping process. The smaller the deflection, the more stable the connection between chassis and trough. On the other hand a stable chassis also provides a stable trough during the tipping process. Conclusion: The smaller the trough deflection, the higher the tipping stability.**

1. Carnehl	270
2. Fliegl	230
3. Kempf	260
4. Langendorf	260
5. Reisch	Only measured on day 1
6. Schmitz	280

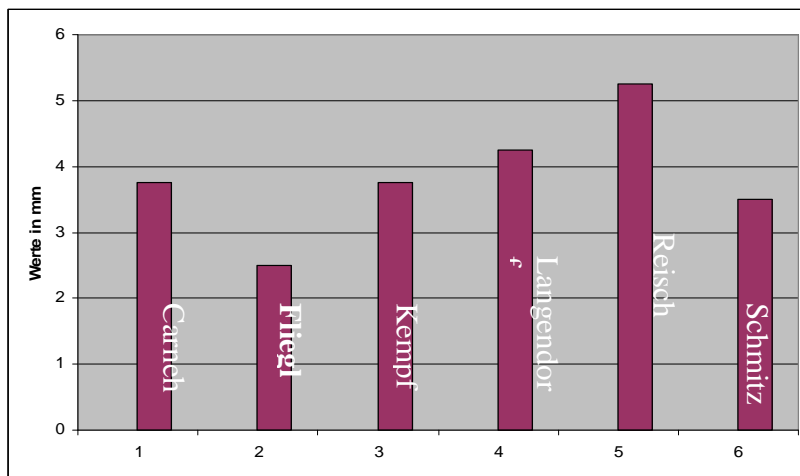
## 2. Torsion vehicle frame over king pin (1<sup>st</sup> test day)

The goal is, to keep the torsion at the front of the dump truck as low as possible during the tipping process. A low torsion on the vehicle also has an effect on the lateral deflection of the trough and on the stability during tipping.

Manufacturer	Values in mm
1. Carnehl	37.50
2. Fliegl	25.00
3. Kempf	37.50
4. Langendorf	42.50
5. Reisch	52.50
6. Schmitz	35.00

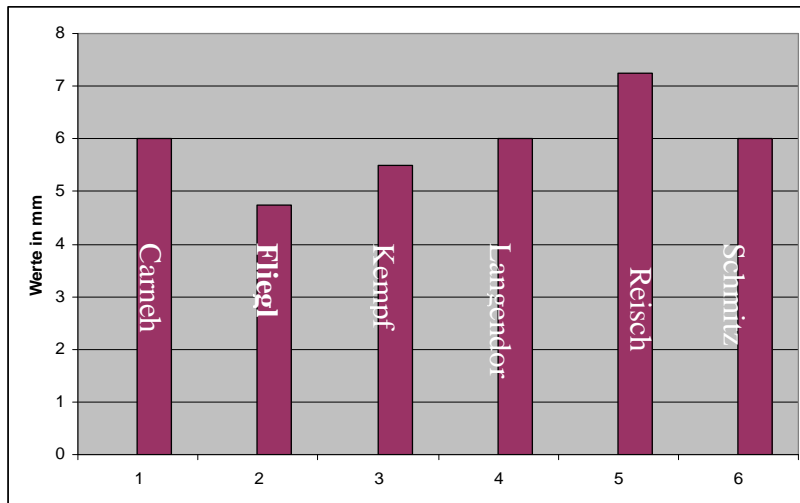
### 3. Torsion vehicle frame over the C axle (1<sup>st</sup> test day)

The torsion at the rear of the dump truck should be as low as possible during the tipping process. The smaller the torsion on the vehicle frame, the lower the lateral deflection of the trough. A smaller value creates better stability of the vehicle during the tipping process.

Manufacturer	Values in mm
1. Carnehl	60.00
2. Fliegl	47.50
3. Kempf	55.00
4. Langendorf	60.00
5. Reisch	72.50
6. Schmitz	60.00
